# Algae prevention in the irrigation pond Tree nursery LUX, Bannewitz near Dresden, Germany

### Baumschule LUX (Tree nursery)

1 Irrigation pond with 4,500 m<sup>3</sup> and 1 OLOID Type 400

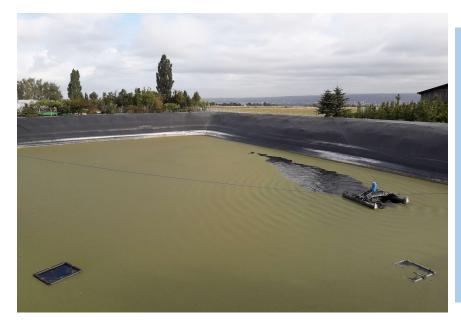
The OLOID Type 400 was fully immersed (the agitator is 100 % under water). The thread algae were prevented by the flow which covers the entire pool. In the photo, which was taken shortly after the installation, you can still see a dense layer of waterweed, which will no longer occur in the future due to the flow of the OLOID. By suppressing the thread algae, the suction filter was only cleaned during routine checks. It was also possible to achieve a significantly higher water throughput.

The above-ground storage basin covered with pond liner has a volume of approx. 4,500 m<sup>3</sup>. Due to the nitrogen input, thread algae grew massively, which clogged the suction filter in the water basin. Cleaning the suction filter was a major maintenance effort, especially in summer 2018. In 2019 an OLOID Type 400 A was used as a test, which prevented the thread algae. The LUX nursery then decided to purchase the OLOID.
