## Water renovation Kynastteich, Berlin, Germany

**Operation  
1 Park ring pond 3000 m<sup>3</sup> with  
OLOID Type 400**

**Period  
Since 08/2015**

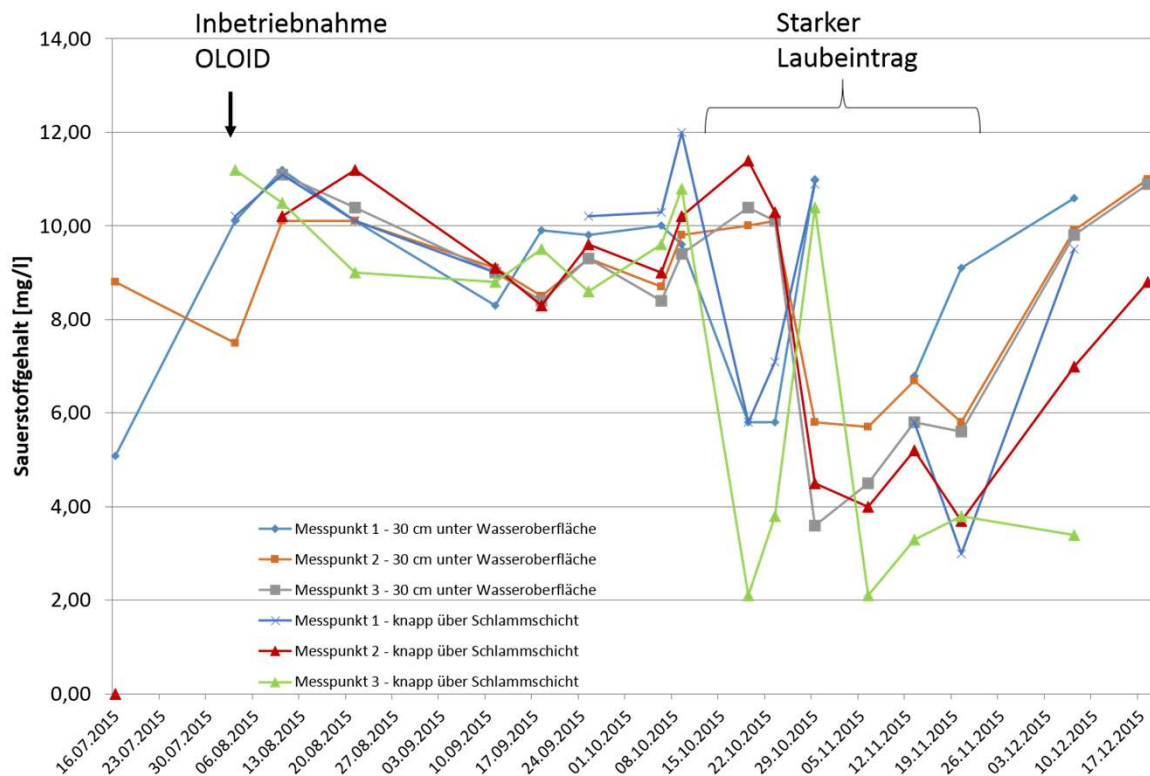
The oxygen measurements show that with initiation of the OLOID, oxygenation takes place. The oxygen content tends to decrease with depth which is typical for standing waters. Here it can be seen that the OLOID initiated oxygenation. Until the middle / end of October 2015 it can be seen that a good to very good saturation is documented of oxygen in water. The end of October / November 2015 lower oxygen levels were measured, this is likely to be linked to the death of aquatic plants and the high foliage entry and thereby initiated ablation process. Mid-December 2015 were again higher oxygen contents and a nearly oxygen saturation measured. Reasons for this are in addition to the operation of the OLOID also in the temperature dependence of both the solubility of oxygen in the water and the microorganisms activity on the other.

Before OLOID installation an additional water entry between 05/20/2015 and 07/15/2015 of approximately 1.176m<sup>3</sup> was done to raise the water level. On 08/03/2015 an OLOID Type 400 was installed. During a 4-month period (until week 50) weekly visual water inspection and oxygen measurements were carried out (results are in the graph on page 3).
